Technical Solutions

“Inadequate USB throughput” message - USB mapping when using multiple cameras.

Products Affected – iXon Ultra, iStar, Clara, Luca, Newton, iDus, iKon
Software Affected – Andor SOLIS

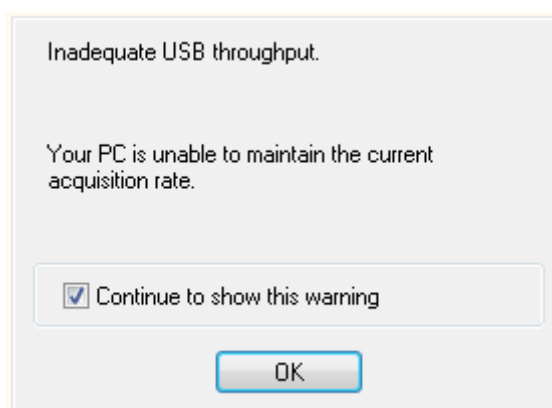
Description of Error: SOLIS displays “Inadequate USB throughput” message when simultaneously acquiring data from multiple Andor USB cameras (*Figure 1*)

Figure 1 – Error message displayed when

To overcome this, each camera will need to be connected to its own dedicated USB 2.0 controller. This can be determined by mapping the PC’s USB ports to see which USB ports are connected to the PC USB controllers. To do this, download the USB Hub Finder tool from the Utilities folder in the software section of MyAndor. You can register for a MyAndor account at: <http://www.andor.com/my/Register.aspx>. Alternatively, if you have Andor Solis installed, the software will be accessible through the Andor Solis installation directory (default location C:\Program Files\Andor SOLIS\UVCView).

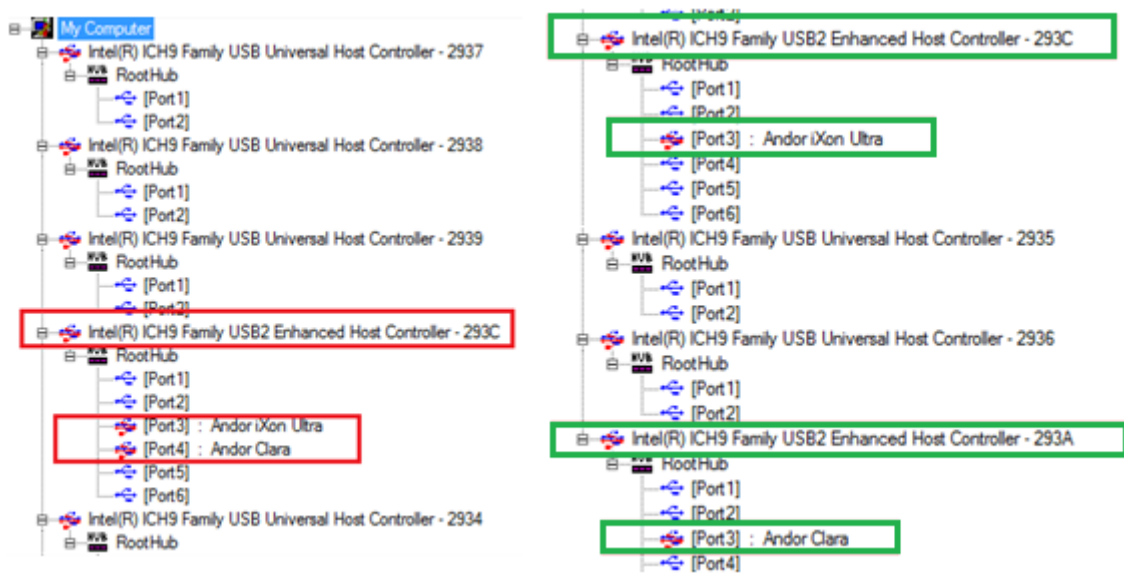
Figure 2 – (left) 2 Andor Cameras sharing a single USB controller port
(right) 2 Andor cameras connected to dedicated USB 2.0 USB controller ports

Ensure the cameras are attached to separate USB 2.0 ports (Figure 2). When each camera has been connected to its own dedicated USB controller port, they will have sufficient USB bandwidth to function simultaneously.
